Electrical Inspection using Infrared
Thermography

Reporter: B&R Licensed Thermographer
January 3, 2023

123 ANY STREET, TORONTO

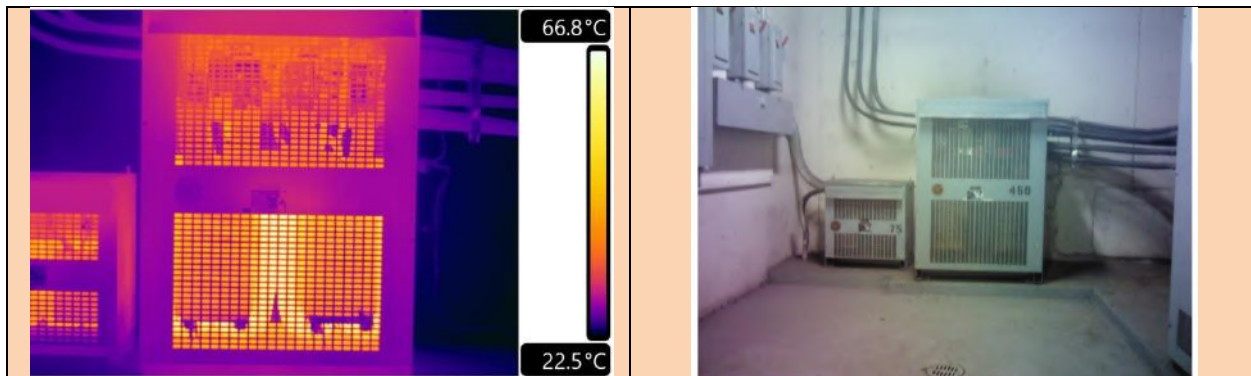
REFERENCE #1

PRIORITY	LOCATION	EQUIPMENT
None	B-1 Sub-Main Electrical Room	450 kVA TRANSFORMER

PARAMETERS		ANALYSIS AND RECOMMENDATION	
File Name	IR_0260.jpg	Equipment	MARCUS Transformer VAC 600 /120/208 V, 3 phase, 60 Hz
Max. Temperature	70.3 °C	Designation	Power Panel 2
Min. Temperature	22.3 °C	Analysis	No thermal variances or visible anomaly detected
Atmospheric Temperature	20.0 °C	Recommendation	For reference, only
Object Distance	2.0 m

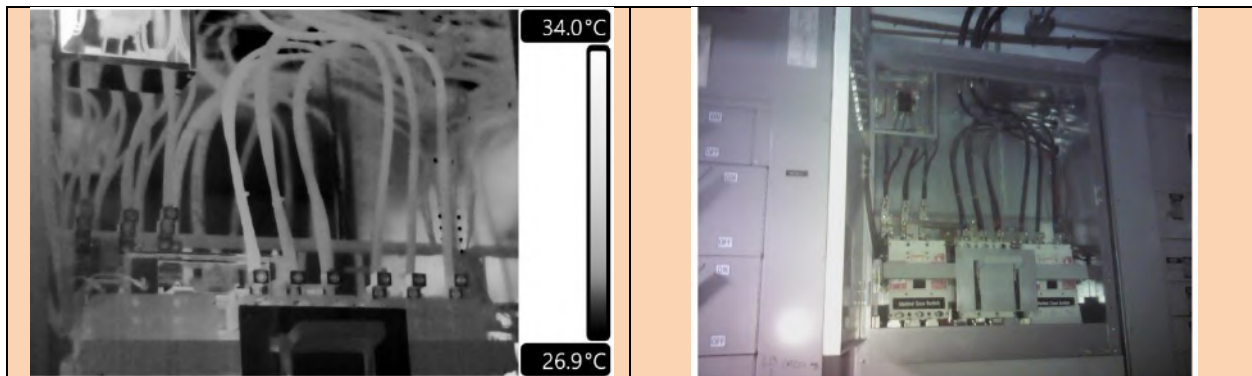
REFERENCE #2

PRIORITY	LOCATION	EQUIPMENT
None	PH Sub-Main Electrical Room	400A AUTOMATIC TRANSFER SWITCH

PARAMETERS		ANALYSIS AND RECOMMENDATION	
File Name	IR_0262.jpg	Equipment	CUTLER-HAMMER 400 A Automatic Transfer Switch VAC 600 V, 3 phase, 60 Hz
Max. Temperature	49.0 °C	Designation	Automatic Transfer Switch-1
Min. Temperature	26.1 °C	Analysis	No thermal variances or visible anomaly detected
Atmospheric Temperature	20.0 °C	Recommendation	For reference, only
Object Distance	2.0 m	Loads	A:18 A B:15 A C:16A

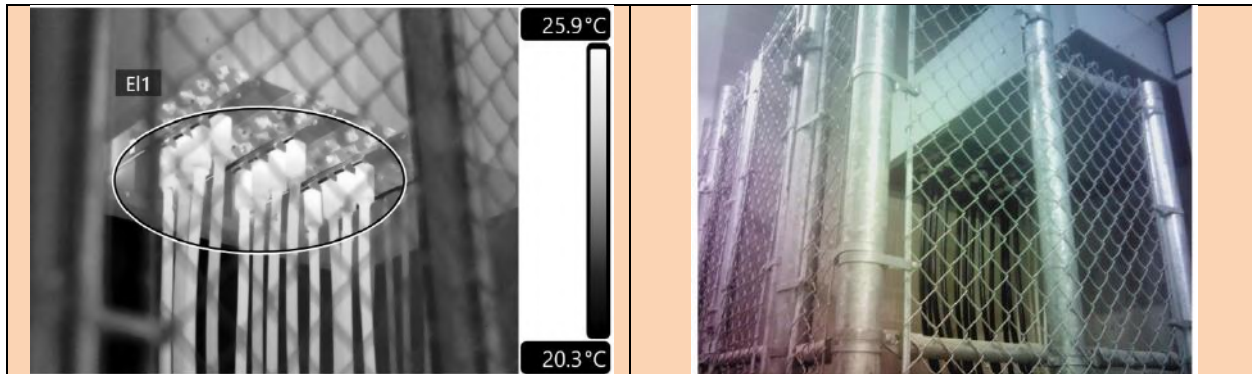
REFERENCE #3

PRIORITY	LOCATION	EQUIPMENT
None	Main Electrical Room	2000 A FEEDERS

PARAMETERS		ANALYSIS AND RECOMMENDATION	
File Name	IR_0264.jpg	Equipment	Incoming Feeders VAC 600 V, 3 phase, 60 Hz
Max. Temperature	26.2 °C	Designation	Main Feeder
Min. Temperature	20.2 °C	Analysis	No thermal variances or visible anomaly detected. E11 was at 26.2° C
Atmospheric Temperature	20.0 °C	Recommendation	For reference, only
Object Distance	2.0 m

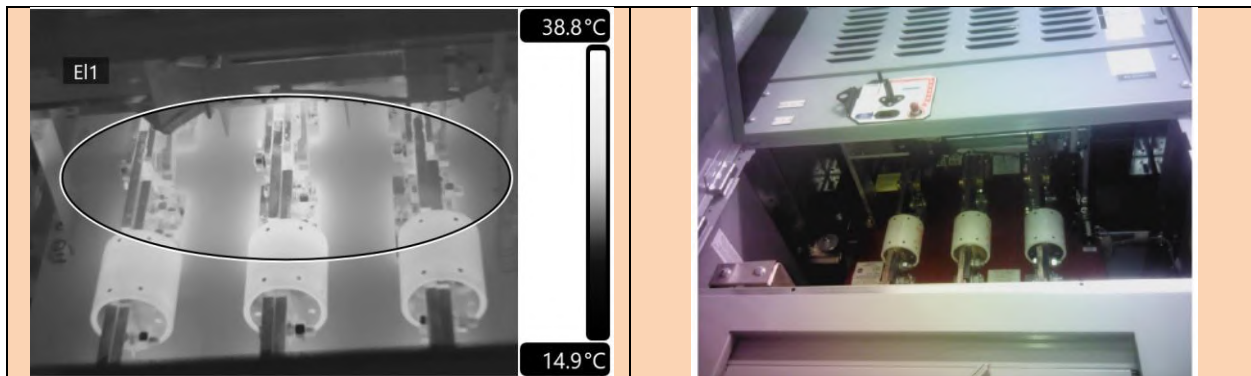
REFERENCE #4

PRIORITY	LOCATION	EQUIPMENT
None	Main Electrical Room	2000A PRESSURE CONTACT SWITCH

PARAMETERS		ANALYSIS AND RECOMMENDATION	
File Name	IR_0266.jpg	Equipment	PRINGLE Pressure contact switch VAC: 600 - 3 phase, 60Hz
Max. Temperature	31.4 °C	Designation	Main disconnect switch
Min. Temperature	21.9 °C	Analysis	No thermal variances or visible anomaly detected E11 was at 31.4° C
Atmospheric Temperature	20.0 °C	Recommendation	For reference, only
Object Distance	2.0 m

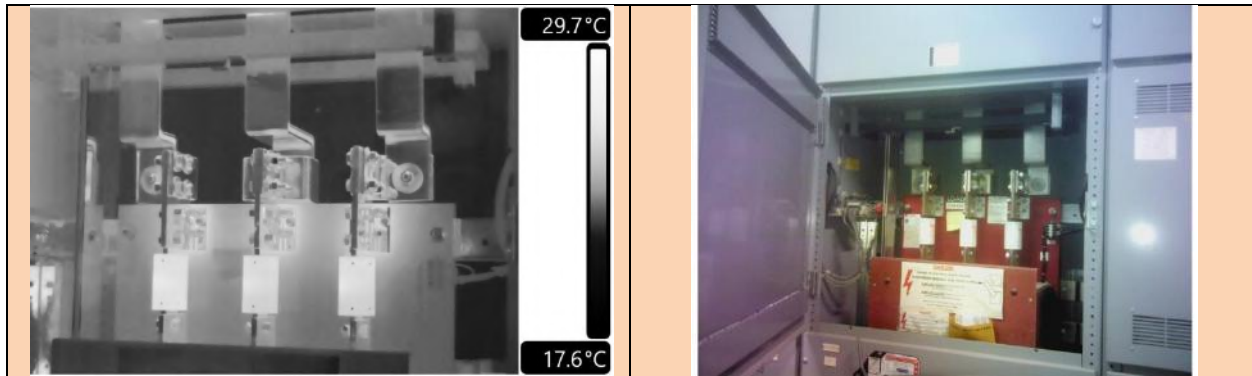
REFERENCE #5

PRIORITY	LOCATION	EQUIPMENT
None	Main Electrical Room	1200A PRESSURE CONTACT SWITCH

PARAMETERS		ANALYSIS AND RECOMMENDATION	
File Name	IR_0268.jpg	Equipment	PRINGLE Pressure contact switch VAC: 600 - 3 phase, 60Hz
Max. Temperature	27.1 °C	Designation	FUTURE – 925 Bay St
Min. Temperature	21.7 °C	Analysis	No thermal variances or visible anomaly detected
Atmospheric Temperature	20.0 °C	Recommendation	For reference, only
Object Distance	2.0 m

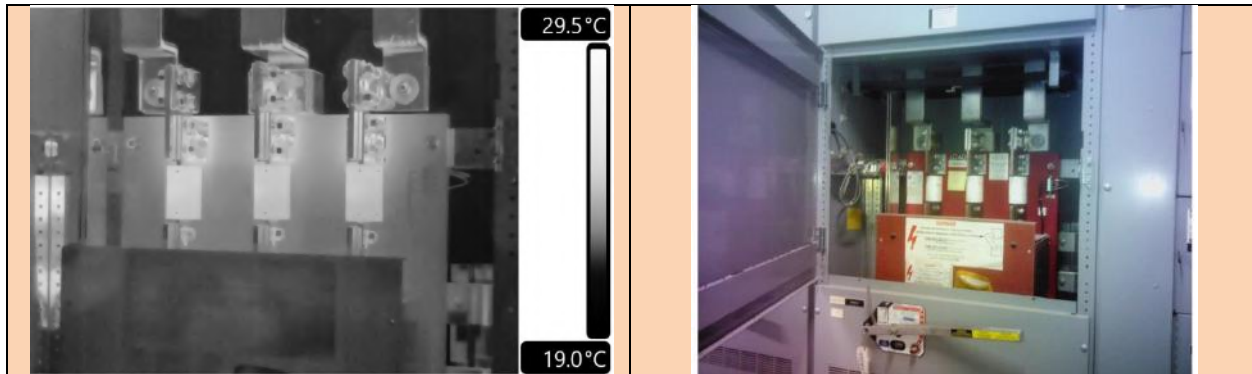
REFERENCE #6

PRIORITY	LOCATION	EQUIPMENT
None	Main Electrical Room	1200A PRESSURE CONTACT SWITCH

PARAMETERS		ANALYSIS AND RECOMMENDATION	
File Name	IR_0270.jpg	Equipment	PRINGLE Pressure contact switch VAC: 600 - 3 phase, 60Hz
Max. Temperature	26.7 °C	Designation	909 Bay St
Min. Temperature	21.1 °C	Analysis	No thermal variances or visible anomaly detected
Atmospheric Temperature	20.0 °C	Recommendation	For reference, only
Object Distance	2.0 m

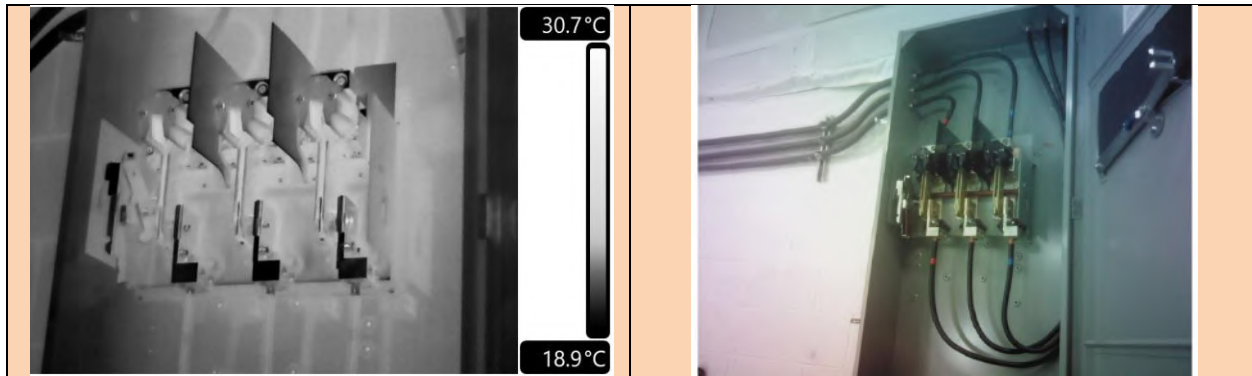
REFERENCE #7

PRIORITY	LOCATION	EQUIPMENT
None	Penthouse Chiller Room	400A DISCONNECT SWITCH

PARAMETERS		ANALYSIS AND RECOMMENDATION	
File Name	IR_0272.jpg	Equipment	FEDERAL PIONEER ELECTRIC Disconnect Switch VAC 600 V, 3 phase, 60 Hz
Max. Temperature	25.1 °C	Designation	Chiller
Min. Temperature	18.4 °C	Analysis	No thermal variances or visible anomaly detected
Atmospheric Temperature	20.0 °C	Recommendation	For Reference Only
Object Distance	2.0 m

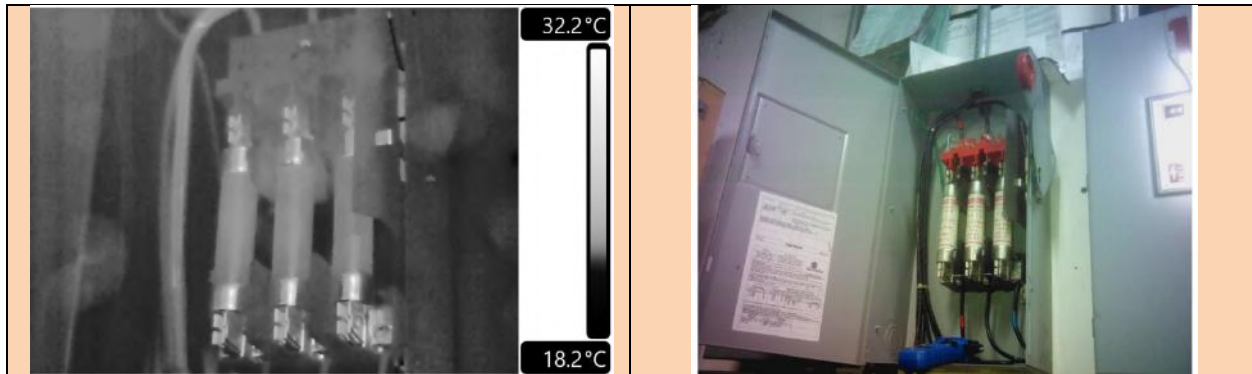
REFERENCE #8

PRIORITY	LOCATION	EQUIPMENT
None	Elevator Machine Room	100A FUSED DISCONNECT SWITCH

PARAMETERS		ANALYSIS AND RECOMMENDATION	
File Name	IR_0274.jpg	Equipment	CUTLER-HAMMER Fused disconnect switch VAC: 120/240 - 2 phase, 60Hz
Max. Temperature	35.8 °C	Designation	Elevator 2
Min. Temperature	21.3 °C	Analysis	No thermal variances or visible anomaly detected
Atmospheric Temperature	20.0 °C	Recommendation	For reference, only
Object Distance	2.0 m	Loads	Varied with elevator operation
